INVESTIGATION OF THE PREPAREDNESS PROGRAM

REPORT BY
PREPAREDNESS INVESTIGATING
SUBCOMMITTEE
OF THE
COMMITTEE ON ARMED SERVICES
UNITED STATES SENATE

ON
THE COLLAPSE OF TEXAS TOWER NO. 4

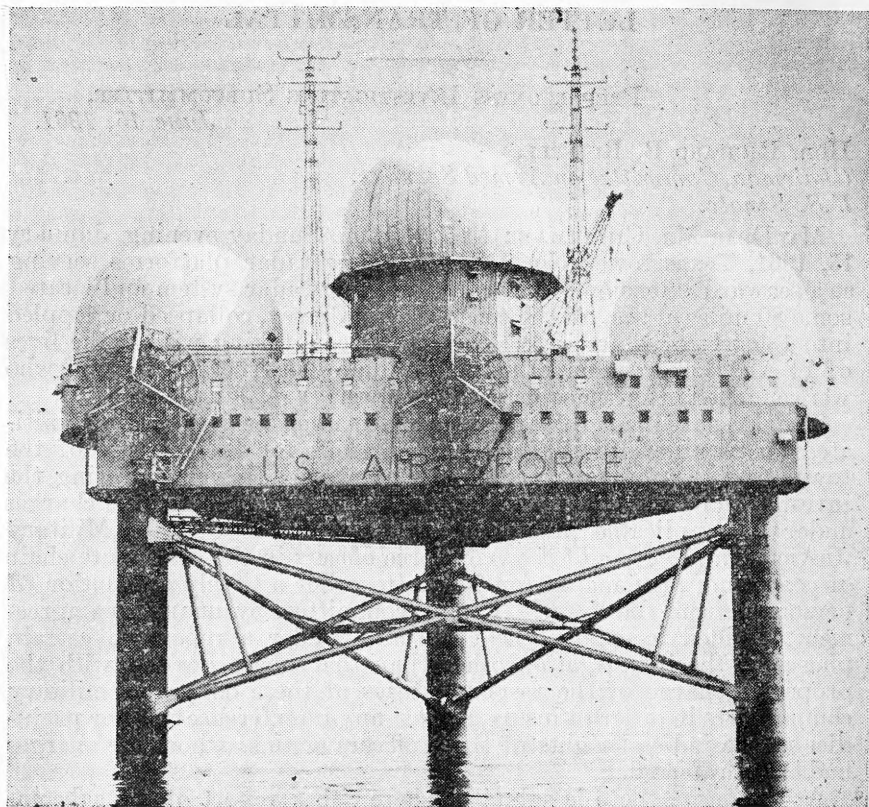
Texas tower No. 4 as it appeared prior to Hurricane Donna, September 12, 1960.

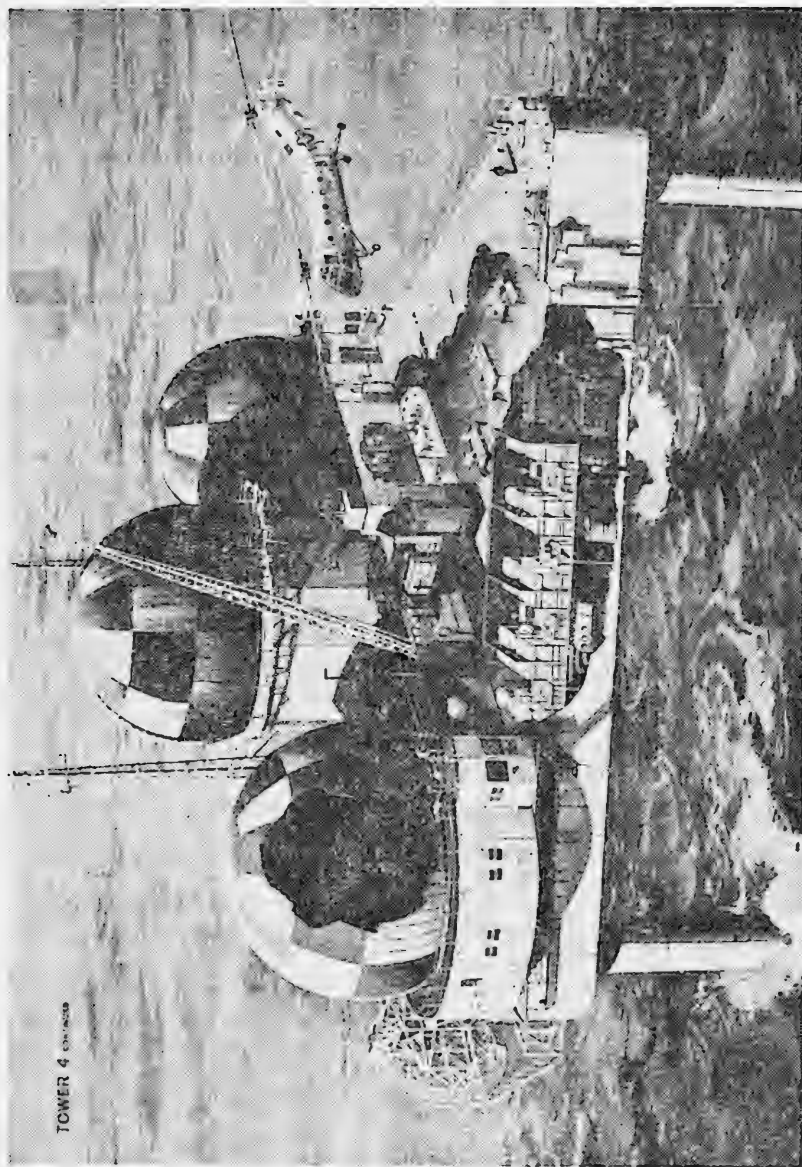
Cutaway view of tower platform (artist's conception).

The legs themselves, in the case of tower No. 4, consisted of an annular ring of steel $1\frac{3}{16}$ inch thick with a diameter of $12\frac{1}{2}$ feet. An inner ring or core of 8 feet in diameter extended from the base of the platform to 50 feet below the surface of the water and it was between those two annular rings of steel that cement was poured to provide greater rigidity.
